# Manhole Inspection Summary

Manhole # S25UU1004MH

Insp Date: **5/3/07 4:00 PM**

**Location** Address: **5101 ROLAND AVE**

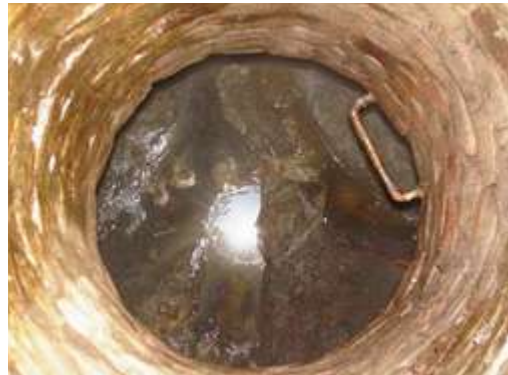
Top View

Corroded and missing steps. Evidence of surcharge - Bench debris. Channel debris.

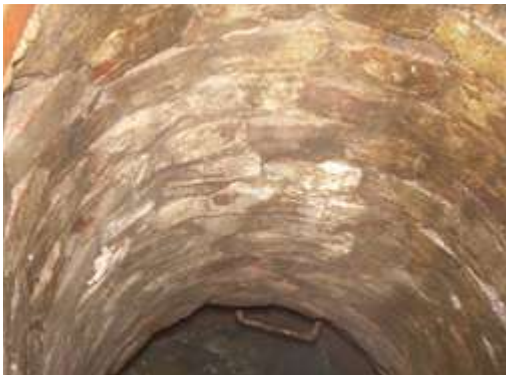
Defect

Adjustment and Corbel infiltration.

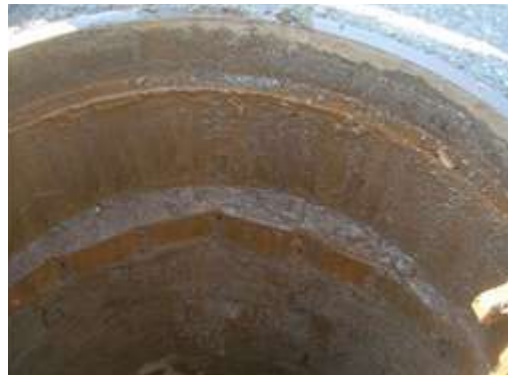
Defect

Frame leaks. Adjustment deterioration and infiltration.

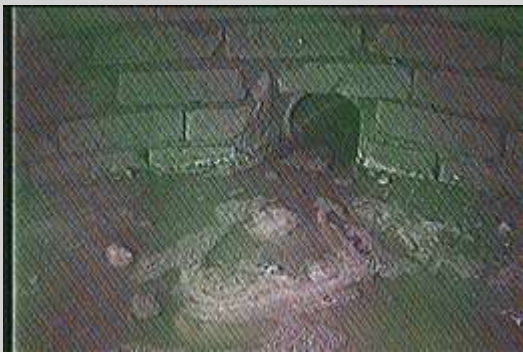
### 8 in. Circular Gravity Sewer Pipe Out @ 12 O'Clock

Deposits: ☐ None ☒ **Mud** ☐ Sludge ☒ **Debris** ☐ Grease

Silt Depth: **0** (in.) Deposits Extent: **Light**

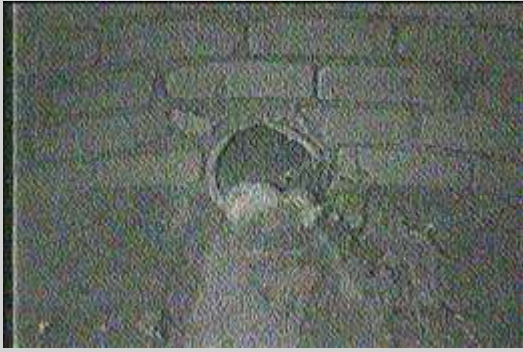
Pipe In @ 6 O'Clock

Deposits: ☐ None ☒ **Mud** ☐ Sludge ☒ **Debris** ☐ Grease

Silt Depth: **1** (in.) Deposits Extent: **Light**

Infiltration: **None** Pipe Seal Cond: **Broken**

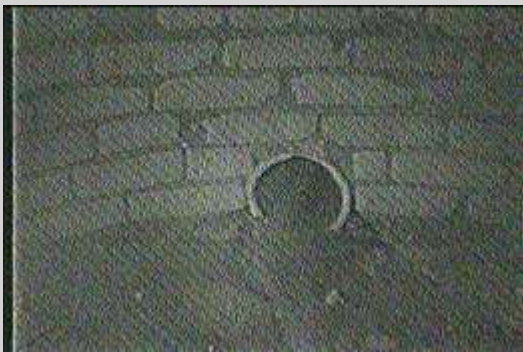
Pipe In @ 8 O'Clock

Deposits: ☐ None ☒ **Mud** ☐ Sludge ☒ **Debris** ☐ Grease

Silt Depth: **1** (in.) Deposits Extent: **Light**
